The Early Cold War Architectural Legacy
at Holloman Air Force Base, New Mexico (ca. 1950-1960)

Holloman Air Force Base
Cultural Resources Publication No. 3

Cultural Resources Publication No. 3

December 1996

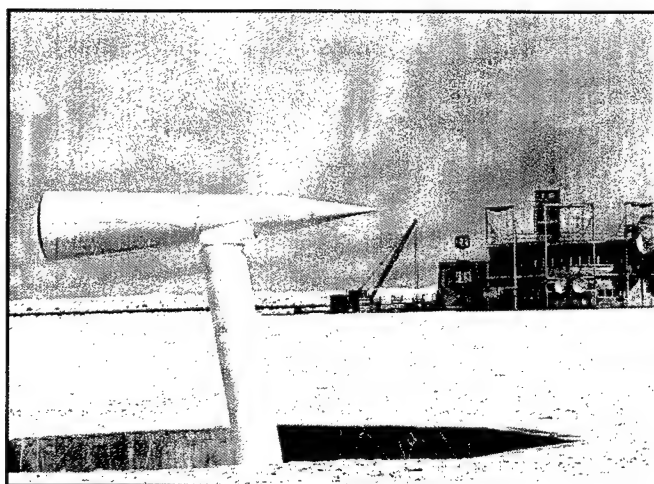
RG 342-B, Vol.2, 06-042, Archives II.

34 This photo (below) shows the tilted column support for the Pershing Nose Cone and a transition or saddle. The tie-down cords serve the purpose of holding the target rigid while it is rotating 360 degrees in azimuth. The building in the right background is the west end of the Radar Target Scatter (RATSCAT) facility.

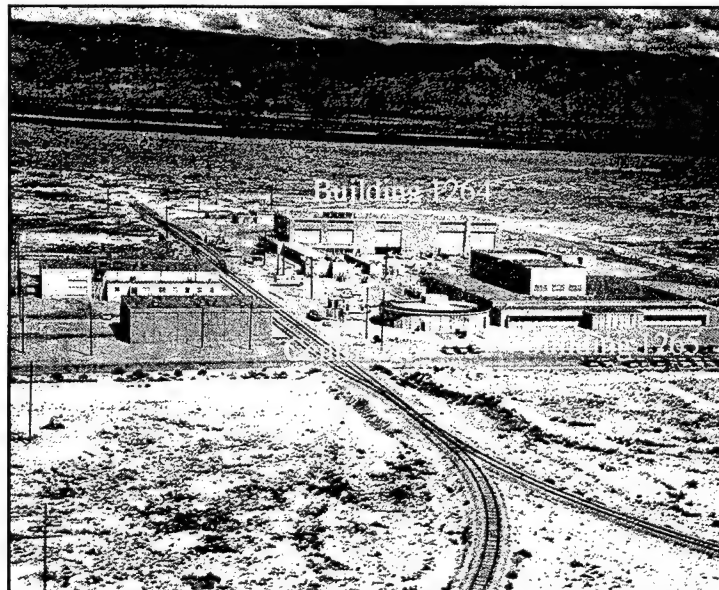
RG 342-B. Vol. II. 06-011.

This aerial oblique taken 21 August 1963 shows Building 1265 (Guidance Test Lab) and the then new circular centrifuge building in the foreground. Building 1264, originally constructed in 1956 as a Static Missile Assembly facility, was converted in the early 1960s for use as a primate research facility. The railroad shown in this photograph has been removed.

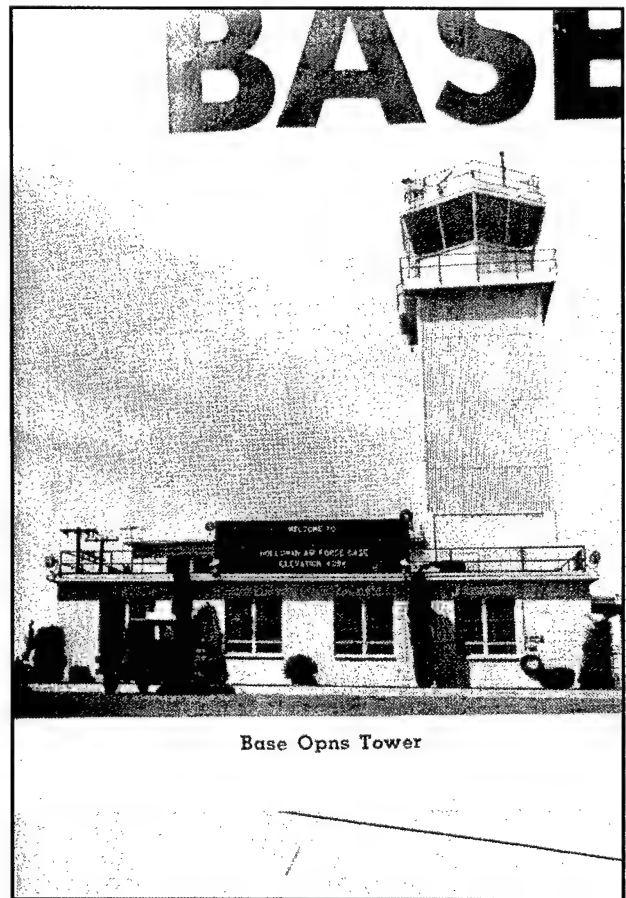
Building 571:

Base Ops Tower

Although the exact date of this photograph is unknown, the source for the picture is the 1958 Holloman Air Force Base Yearbook.

Comments: Building 571 no longer retains historic integrity.

The control tower is no longer being used. Building 571 is used now for weather operations. Plotting and map rooms have been renovated for use as an officer's lounge. Parachute and bag rooms are now used as offices for airfield management personnel. Second floor radio, message, and "crypto" rooms noted on original blueprints are vacant. Control tower interiors have been gutted. Carpeting and vinyl tile cover the original concrete flooring. Several windows have been removed. Nearly all the original wood panel doors have been removed. At least four interior partitions have been added. At least four interior partitions (including those with windows) have been removed. A picket fence shown in drawings dated 1957 has been removed. A jib crane and antenna assemblies are no longer present at the tower. Although abandoned, the control tower appears from the exterior to be the most intact feature of Building 571. Original corrugated cement asbestos siding is still intact as are twenty double-glazed control tower glass panels. Although not eligible, recommend complete documentation through photographs prior to any future modifications, due to this building's uniqueness.

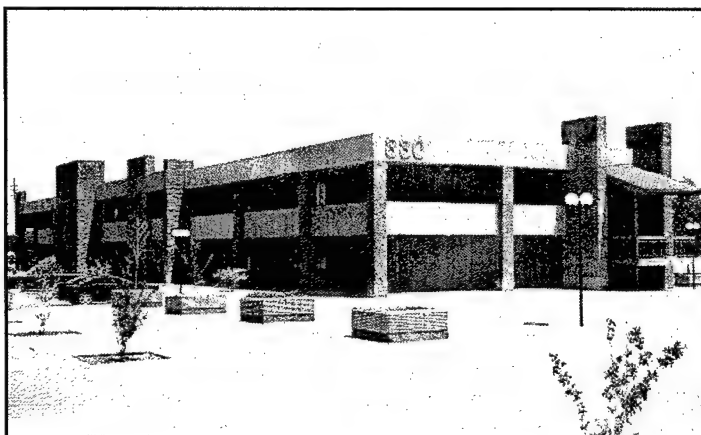
Comments: Building 330 no longer retains historic integrity.

Real Property Accountable Record/330 indicates that this dormitory was completed c1953. August A. Neuner was the architect. Frank Tatsch was the builder. This two-story concrete frame building originally showed symmetrical fenestration, and a flat roof. "As-built" construction drawings document that this building was modified in 1990. The entire building was essentially gutted except for its structural concrete frame. Balconies and stairwells were added. Windows were replaced with doors. New exterior drywall partitions using an EFIS system replace CMU walls. Precast concrete fascia panels at balcony were also added. The dormitories were landscaped, and walkways added. The original foundation was modified at this time also. Construction drawings for the original building, and subsequent renovations, are located in CE File #333, and #330.

Although Building 330 continues to function as a dormitory, this building has lost most of its integrity of design, setting, materials, and workmanship. Although only a few rooms were accessed, HAFB personnel verified that all rooms were renovated with new walls, flooring, and ceilings. Sliding windows with aluminum frames replaced original windows, with different locations and sizes throughout. Private exterior doors were added to each room, versus the old dorm style of entering through a lobby, and then accessing rooms through interior corridors. New planters, sidewalks, and pavers were constructed on West Connecticut Avenue to serve as a pedestrian mall. Upgraded landscaping and grading around the building appear to be in good condition.

Suggested routine maintenance: Efflorescence noticed on stucco in some areas. Moisture noticed on balcony ceiling, all floors. Water leakage possibly starting at roof and balcony parapet, or original building/balcony roof connection. Check cant strip and flashing at roof interfaces.

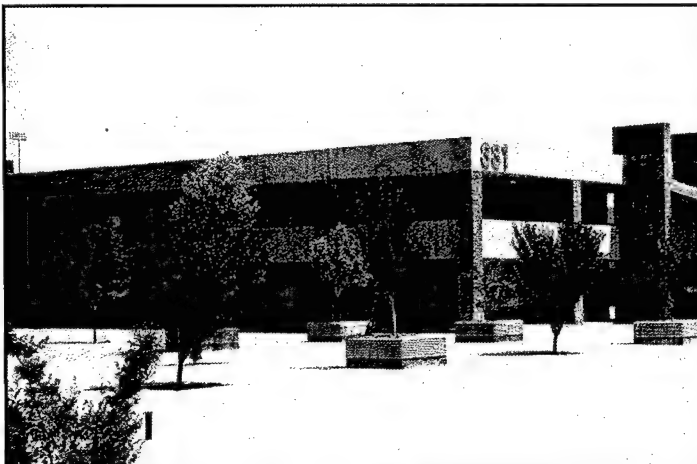
Comments: Building 331 has lost historic integrity.

Real Property Accountable Record/331 indicates that this dormitory was completed c1953. August A. Neuner was the architect. Frank Tatsch was the builder. This two-story concrete frame building originally showed symmetrical fenestration, and a flat roof. "As-built" construction drawings document that this building was modified in 1990. The entire building was essentially gutted except for its structural concrete frame. Balconies and stairwells were added. Windows were replaced with doors. New exterior drywall partitions with an exterior finish and insulation system (EFIS) replace the original concrete masonry unit (CMU) walls. The dormitories were landscaped, and walkways added. The original foundation was modified at this time also. Construction drawings for the original building, and subsequent renovations, are located in CE Files #333 and #330.

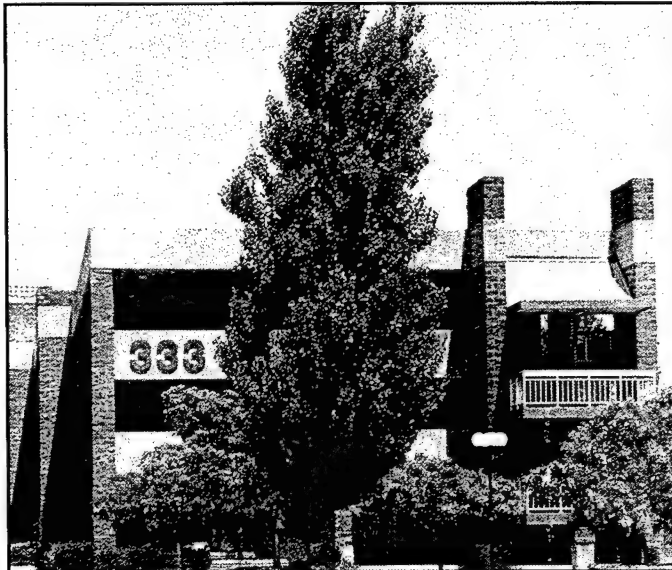
Comments: Building 333 has lost historic integrity.

Although Building 333 continues to function as a dormitory, this building has lost most of its integrity of design, setting, materials, and workmanship. Although only a few rooms were accessed, HAFB personnel verified that all rooms were renovated with new walls, flooring, and ceilings. Sliding windows with aluminum frames replaced original windows, with different locations and sizes throughout. Private exterior doors were added to each room, versus the old dorm style of entering through a lobby, and then accessing rooms through interior corridors. New planters, sidewalks, and pavers were constructed on West Connecticut Avenue to serve as a pedestrian mall. Upgraded landscaping and grading around the building appear to be in good condition.

Suggested routine maintenance: Efflorescence noticed on stucco in some areas of each of the Airman's dorms. Moisture noticed on balcony ceiling, all floors. Water leakage possibly starting at roof and balcony parapet, or original building/balcony roof connection. Check cant strip and flashing at roof interfaces.

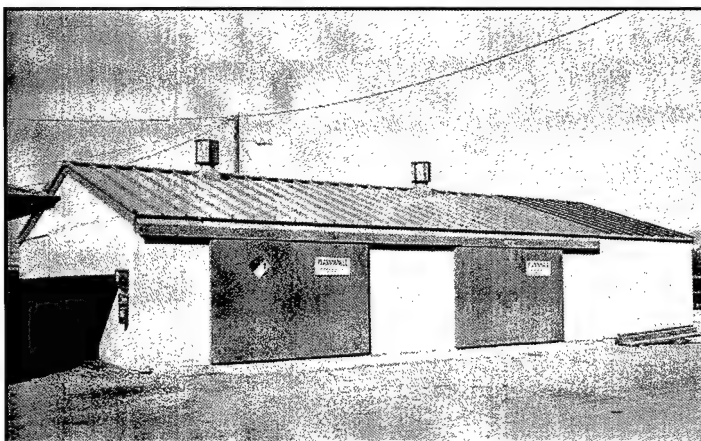
Although original construction drawings were not located, Building 60 shares several features with similar buildings built in the mid 1950s, including footprint layout, and structural and architectural features. These features do not appear to have been modified. According to CE File # 55-1/ Sheet 2, dated February 1972, Building Numbers 60, 65, 63, 62, 51, 59, and 58 were all relocated prior to the construction of the Base Civil Engineer's Maintenance Shop. Construction drawings for all of these buildings, including Building 60, are missing from the Civil Engineering blueprint files. The Steelox® wall and roof system, Armco® flashing, sliding doors, and metal frame windows appear as features of similar buildings constructed in the mid- 1950s. The rear elevation is obscured by a chain-link fence enclosure. The interior is partitioned into two spaces. The smaller space has a dropped ceiling, while the larger space maintains the exposed Steelox®.

Suggested routine maintenance: Regrade at foundation to promote positive drainage. Scrape, prime, and paint wall at junction box. Scrape, prime, and paint the slider doors.

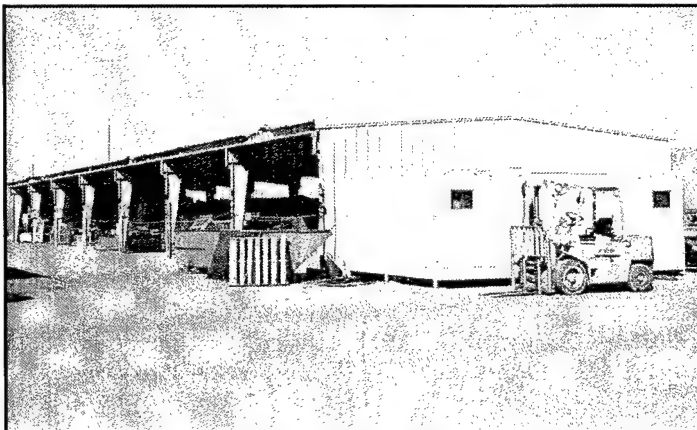
Building 113 is an open-sided, prefabricated metal shed using steel bent frame construction with metal panels on the gable roof. Real Property Accountable Record/113 indicates that this structure was completed c1954. Neither an architect nor a builder are noted on the one construction drawing located for this shed (c1964: CE File #113-1). This drawing indicates that footings, bent frames, purlins, sag rods and metal roof panels were added to the original concrete slab on grade. (c1964: CE File #113-1).

Suggested routine maintenance: The steel columns have incurred moderate to heavy forklift damage. These columns must be checked for plumbness and structural integrity if subjected to additional loads. Each column base connection should be inspected. Loose metal roof and siding panels need to be reattached.

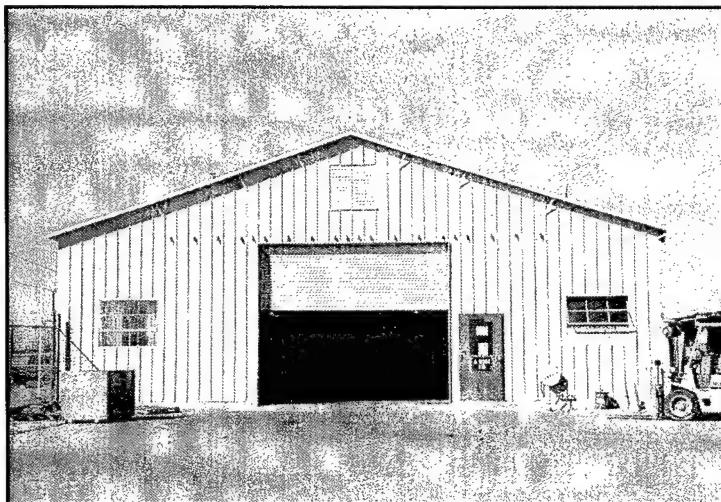
Suggested routine maintenance: Broken window glass needs to be replaced. Metal siding needs minor repair work. The concrete foundation is cracked and spalling in areas. A steel frame supporting the air conditioning unit (outside the building at the north end) has rusted and must be shored or replaced. Vegetation should be removed at the foundation. Several areas around the foundation should be regraded to promote positive drainage (water runoff away from the structure). Ruts and tears in paving repair work around Buildings 113 and 115 indicate an incorrect asphaltic mix and installation for the present traffic loading. Recommend the top surface be removed to the base coarse, additional base added and compacted, and tack coat added.

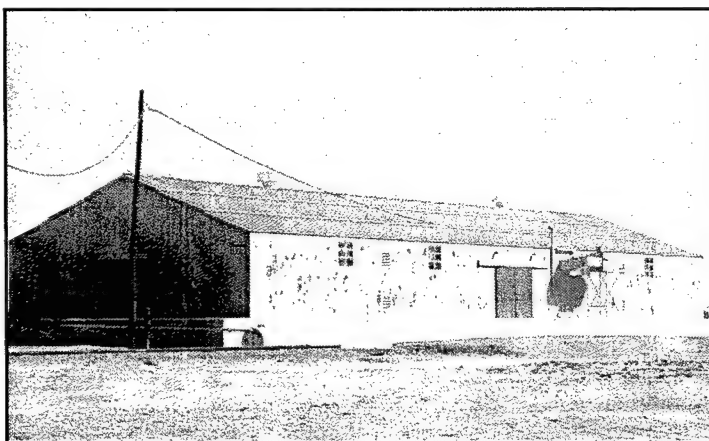
Building 375's exterior shell was manufactured by the Parkersburg Rig and Reel Company, Parkersburg, West Virginia, according to a metal plate mounted on the south elevation wall. No structural modifications to the original structure noted. Although no "As-built" drawing were located for Building 375, subsequent drawings note minor alterations to the original design.

The exterior shell of this one-room prefabricated steel shell and structure was manufactured by the Parkersburg Rig and Reel Company, Parkersburg, West Virginia, according to a plate mounted on the south elevation wall. This building provides an intact example of prefabricated structures being shipped cross-country to fulfill storage requirements during the Cold War military buildup, and may warrant further research as such. Although not eligible as an individual property due to its ancillary role, recommend that this facility be photographed prior to major modifications. It is worth noting that goods were apparently delivered via railroad to this warehouse. A railroad grade is located adjacent to Building 375, although this railroad system has been abandoned. The front elevation historically faced the railroad (n.d.: CE File #375-1). Building 375 is currently accessed at the north elevation loading dock. Interior steel columns support large steel trusses, which are all exposed. The truss span is approximately 50 feet. The building length is approximately 133 feet, and the clear height (top of slab to bottom chord of truss) is approximately 12 feet. The interior steel columns and walls are covered with a fiber fireproofing material. Electrical and mechanical systems are exposed. Sliding doors and windows are all original. The sole modification to the original plans includes the partitioning of a receiving room and a latrine at the entrance. These wood stud partitions represent a minor modification, and are removable.

Suggested routine maintenance: Scrape, prime, and paint exterior. Repair torn roofing at south gable.

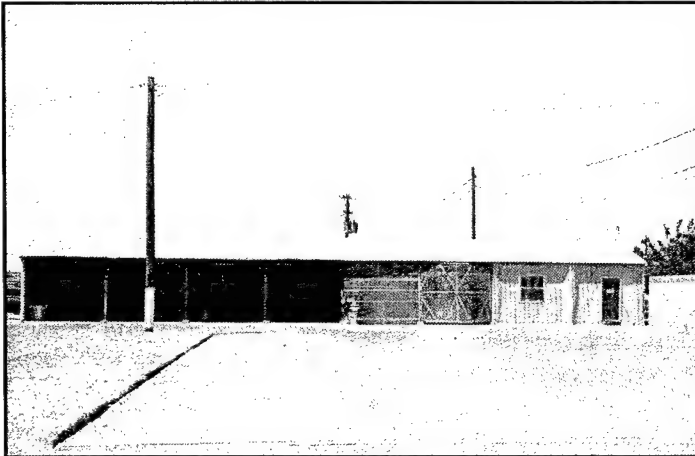
Suggested routine maintenance: Reattach metal siding at south and east elevations. Existing damage to the columns should be monitored. Further use of this shed for parking may require that the columns be replaced and/or strengthened.

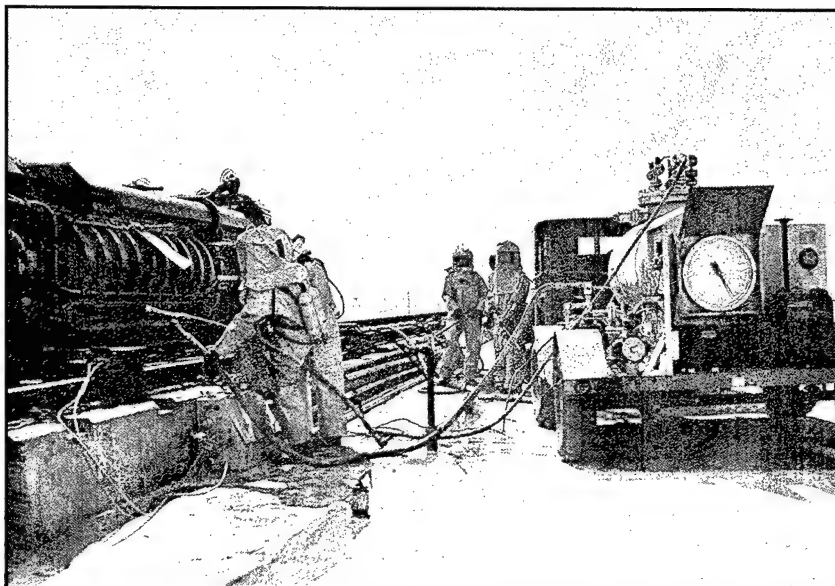
RG 342-B. Vol. I. 03-056. Archives II.

“A fueling crew from the Propellant Branch is shown during the fueling of the acid sled in preparation for a firing on the Captive Missile Test Track at the Air Force Missile Development Center, Holloman AFB. The operation involves the transfer of 350 gallons of red fuming nitric acid from the fueling trailer to the sled, and elaborate protective clothing must be worn when handling nitric acid.” US Air Force photo 18 February 1960.

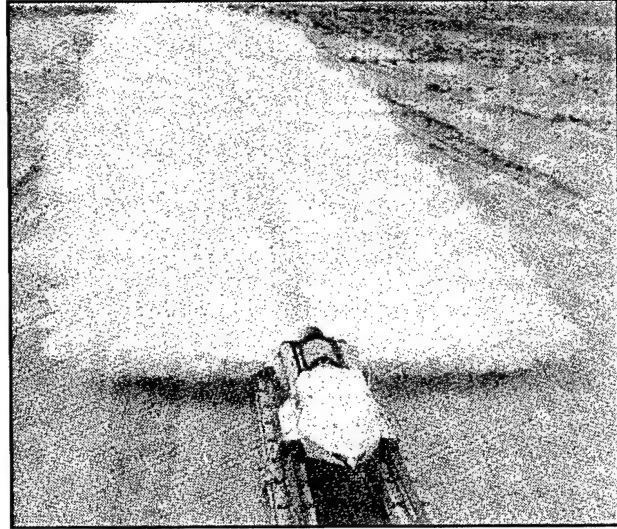
(Above) Large test sled is decelerated by water brake at Holloman, AFB. (Left) Simulated rain environment, High Speed Test Track.

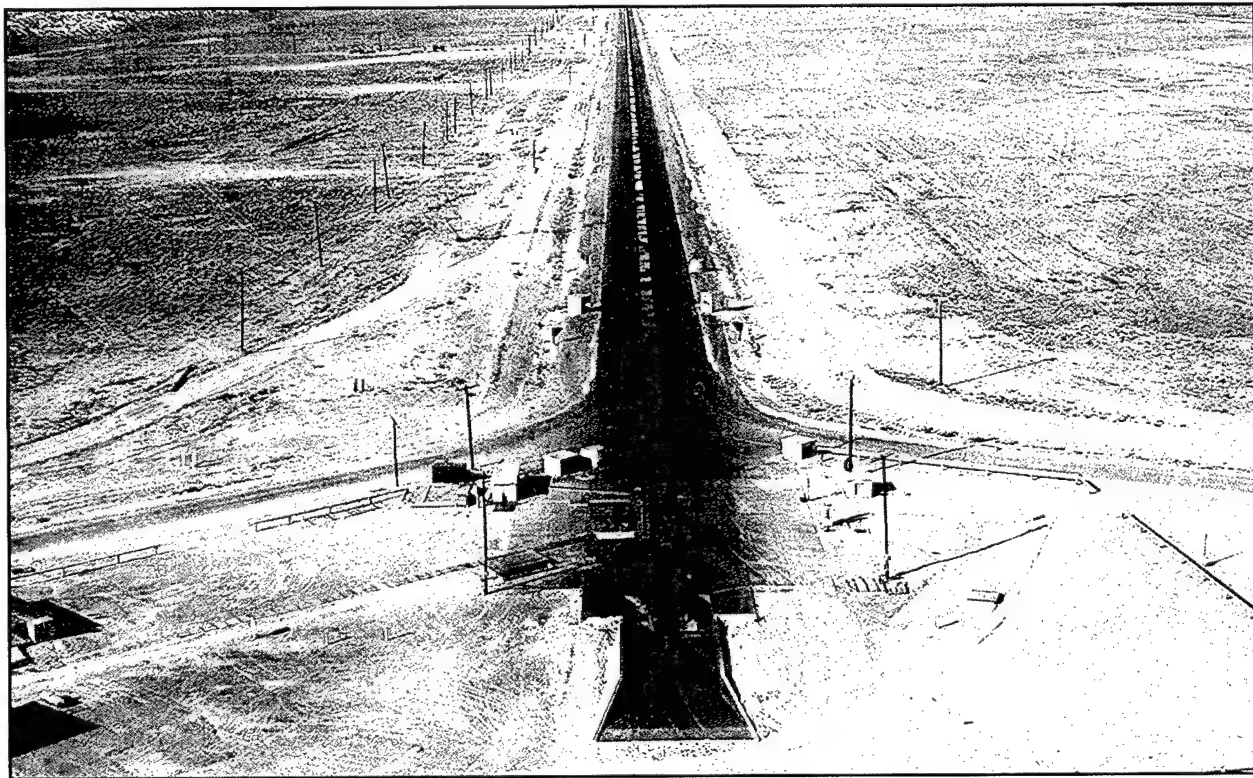
RG 342-B. Vol. II. 06-042. Archives II.

“Holloman’s 35,000 foot High Speed Test Track. Water is used between the tracks to brake the test sleds. A 6,000-foot stretch of the track has been fitted with 24,000 feet of aluminum pipe and 1,500 nozzles in order to pour 5,000 gallons of water per minute on rocket sleds in tests to evaluate rain erosion effects on missile nose cones and re-entry vehicles.” U. S. Air Force Photo 10 Sept 1962.

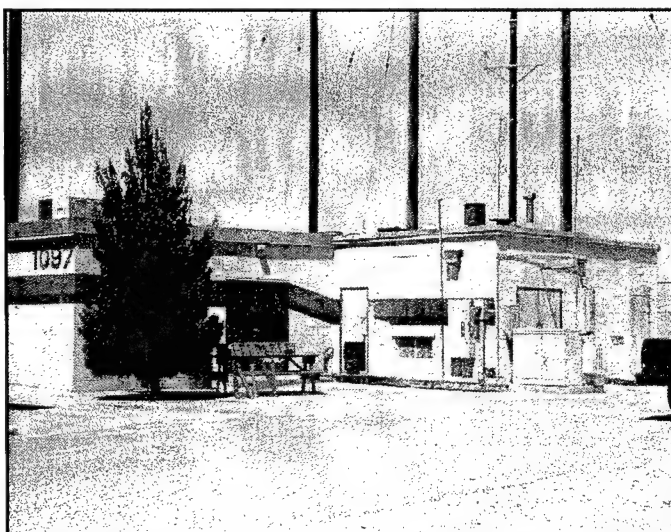
Comments: Building 1097 has not retained historic integrity.

Building #1097 retains its original function as a radio receiver facility, however it has been modified to accommodate electrical, mechanical, and equipment additions and change-outs. Original equipment has been replaced.

Office space was added to the south elevation (1986: CE File #1097-1). All six windows at the north, east and west elevations have been blocked in. Original doors have been replaced. Vinyl floor tile covers original tile throughout. Dropped ceilings have been added.

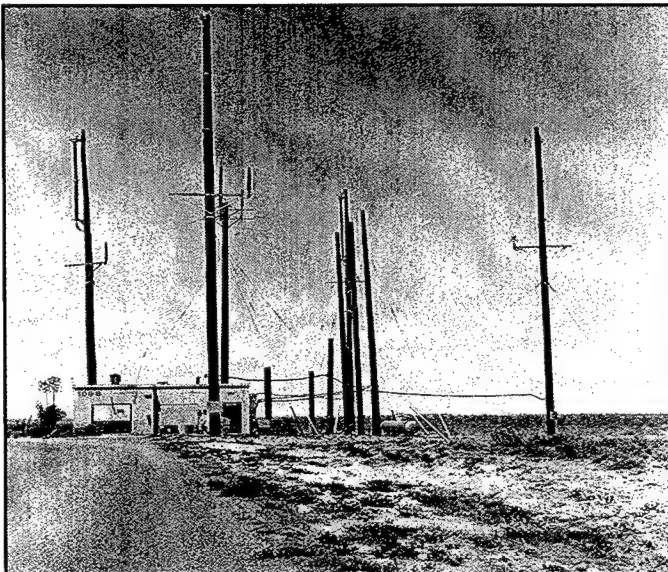
Comments: Building 1098 has not retained historic integrity.

This single story, utilitarian, concrete masonry unit structure exhibits a flat roof, and is asymmetrically fenestrated. The principal elevation faces southeast. Building 1098 shares the same floor plan as the original Building 1097. Real Property Accountable Record/1098 gives an estimated completion date of 1953. Both the builder and the architect are unknown. No structural modifications to the building were noted.

The original floor covering and cable trench that runs in the floor are still visible. Steel joists that support the roof are exposed. Construction drawings dated c1952 (CE File #1098-1) show four interior functions, including a transmitter room, a heater room, a store room, and a generator room. These functions remain essentially the same. Communications equipment currently in use replaces original communications equipment.

Suggested routine maintenance: Prune plantings at southeast corner of building, or replace with smaller varieties. Remove sandbags from the roof.

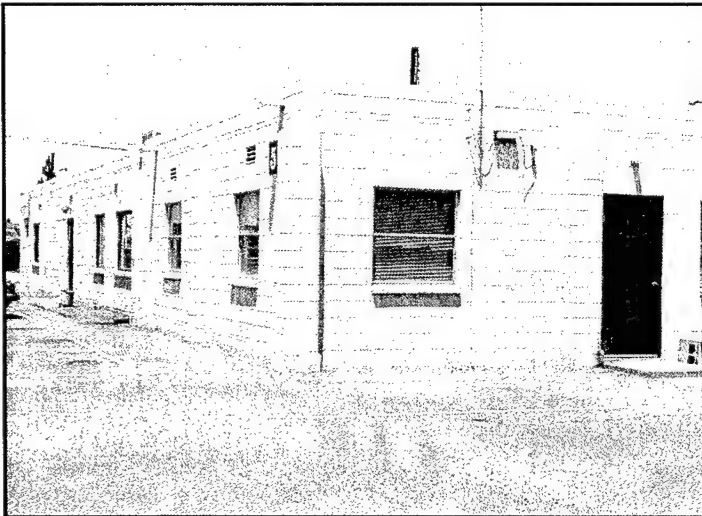
Comments: Evidence of interior water damage. Repair & maintenance needed.

Comments: Building 57 no longer retains historic integrity.

Structural and architectural modifications to Building 57 render it ineligible for the National Register of Historic Places. Similar materials and design features from the original structure were incorporated into an addition at the south elevation (1973: CE File #57-2). Every original window, shown on early drawings as 12- and 16-light metal windows, has been replaced with double-hung, 2-light, aluminum frame windows matching the addition. One original door is blocked from use. At least three interior doors have been removed. Sheetrock® covers the original painted block walls at the interior. Remnants of plaster ceilings, glazed tile in the latrines, and mineral tile in the lab room are the only notable interior finishes remaining.

Suggested routine maintenance: Extensive water damage evident at the dropped ceiling, and at the base of several block walls indicate that repairs to the roof may be necessary. Replace torn window screens. Replace broken window and door panes. Patch holes in wall to the left of the main entrance. Clean curb gutter. Scrape, prime, and paint exterior. Replace wooden platform at air conditioning unit. Regrade at foundation to promote positive drainage.

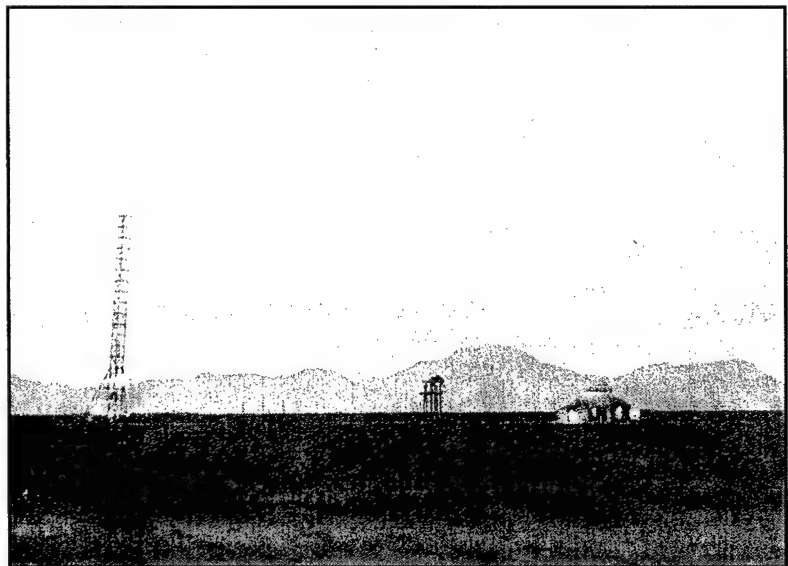
RG 342-B. Vol. I. 06-011. Archives II.

This U. S. Air Force photograph showing an X-8 Aerobee guided missile launch was taken c1955.

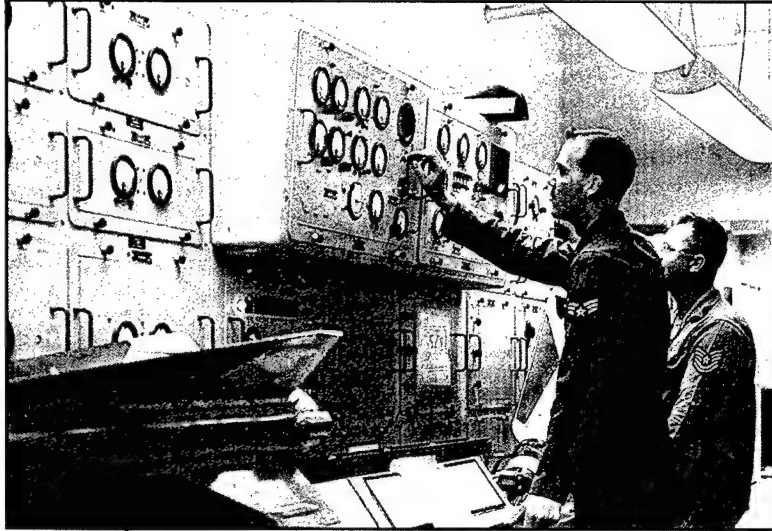
RG 342-B. Vol. II. 06-042. Archives II.

(Above) "U. S. Air Force personnel check out a Hughes GAR-1 'Falcon' air-to-air guided missile on a test table at Holloman Air Development Center, Holloman Air Force Base, NM 18 October 1955." U. S. Air Force photo. News releases at this time broadcasted the results of Holloman AFB tests using the Falcon GAR-2A to successfully intercept another guided missile, the Matador TM-61A.

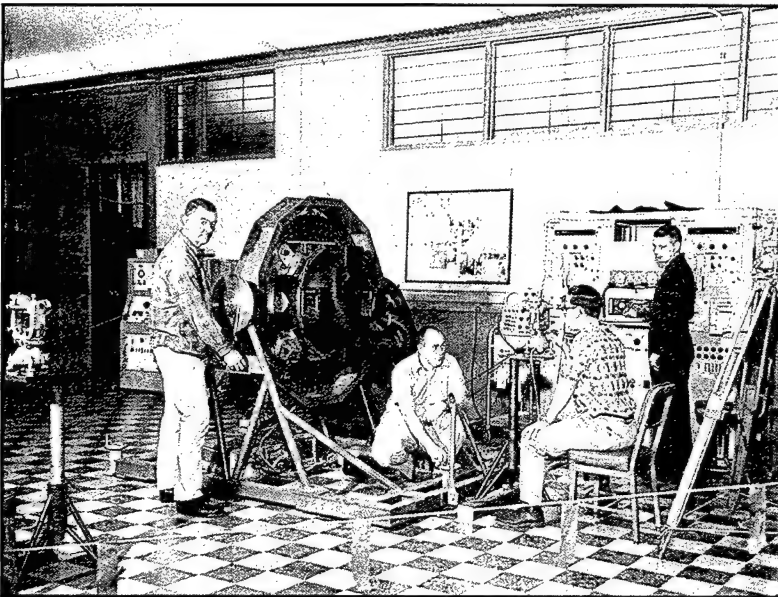
RG 342-B. Vol. I. 03-057. Archives II.

In this U. S. Air Force photograph dated 18 January 1963, a missile guidance package is being aligned and calibrated prior to being mounted into the forebody of sled for a High Speed Test Track run.

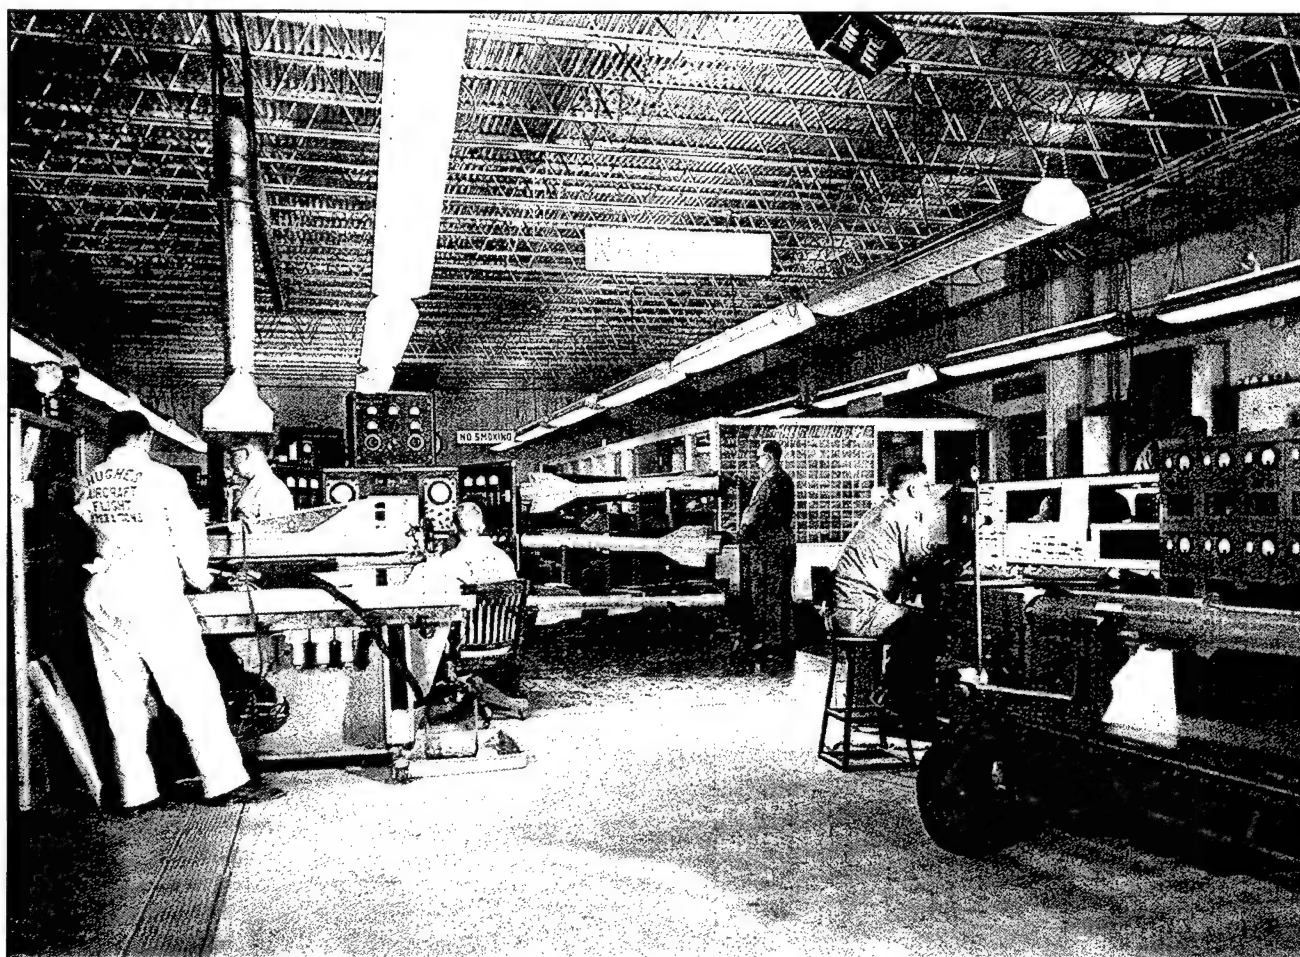
RG 342-B. Vol. II. 06-042. Archives II.

"Hughes Aircraft Company technicians and Air Force personnel work on a GAR-1 'Falcon' air-to-air guided missile in the test laboratory at Holloman Air Development Center, Holloman AFB, NM 21 October 1955." U. S. Air Force photograph.

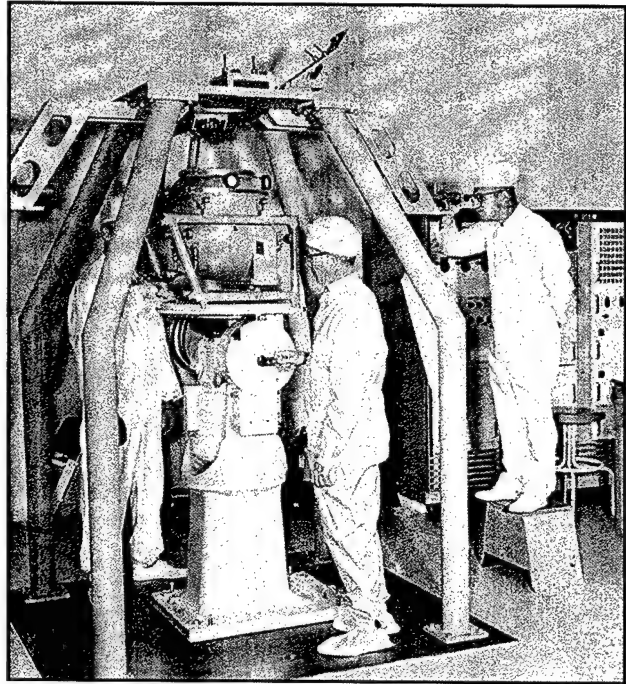
RG 342-B. Vol. II. 06-011. Archives II.

(Right) "As the first step in the construction of a Celestial-Inertial Test Complex at the Air Force Missile Development Center, Holloman AFB, NM a package unit 37 feet 8 inches square by 14 feet high was built inside the high-bay area of the Central Inertial Guidance Facility. Here, Controlled Environmental Area personnel are at work on calibration procedures 25 March 1963." U. S. Air Force Photo.

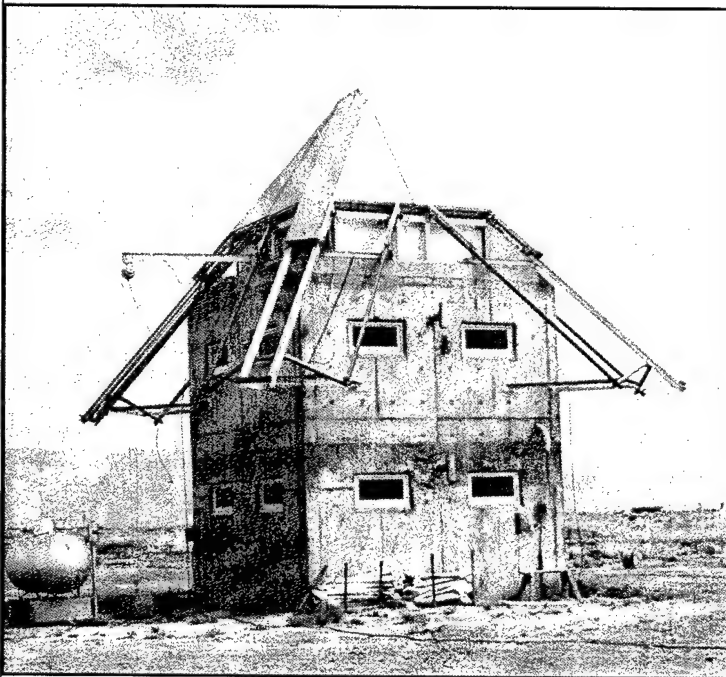
RG 342-B. Vol. II. 06-042. Archives II.

(Left) Cinetheodolite shelters with moveable roof sections were constructed to provide visual tracking of guidance missile flights. This photograph was taken on 8 October 1955. U. S. Air Force photo.

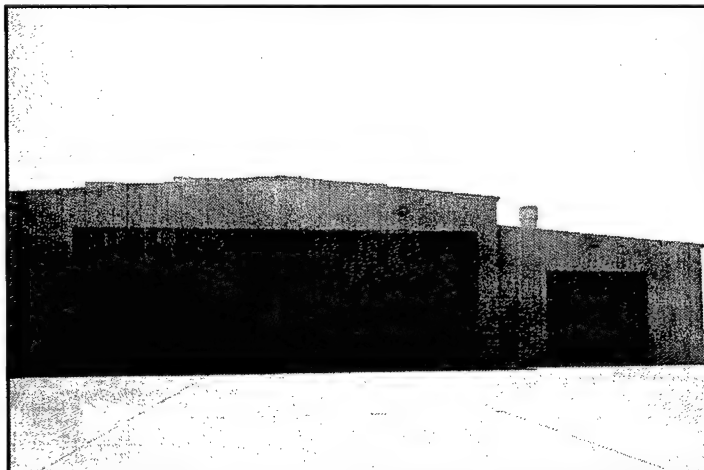
Comments: Although well-maintained, building is in need of minor repairs.

Suggested routine maintenance: This building appears to be well-maintained. Minor scraping, priming, and painting required at the exterior. Repair broken window panes.

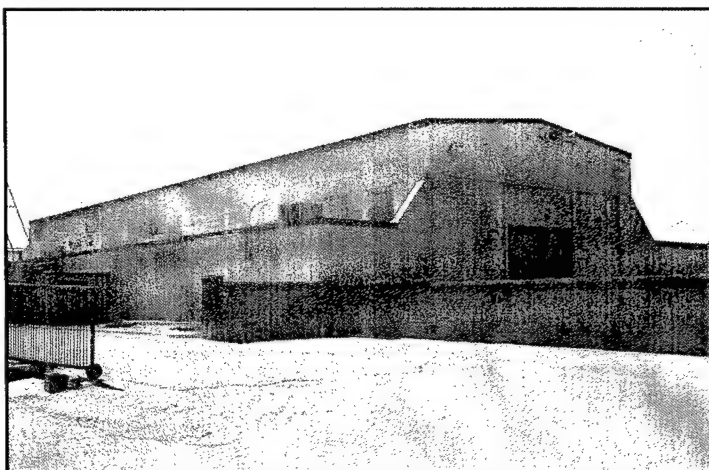
None of the construction drawings for Building 822 are correctly stamped "As-Built." Modifications to the original structure are evident, however, at each elevation, and at the interior. At the gable ends, the original roll-ups have been framed in and covered with fiberboard sheathing. Smaller roll-up doors have been cut into the original doors. Most of the original access doors have been replaced with new doors or removed completely. Several new doors have been added to the exterior. A steel smokestack has been removed from the west elevation. Early improvements include a single-story addition at the north elevation. This improvement was subsequently partitioned at the interior. Despite the modifications, most of the original design and materials remain evident. The most prominent features include the glass block windows at the second level, and the exposed steel trusses in the high bay area. Recommend that this building be reassessed once the fifty-year construction date is reached in the year 2002, and that modifications in the interim do not irrevocably alter any essential design features.

Suggested routine maintenance: Interior water damage may indicate failure at the roof. Re-grade at foundation to promote positive drainage. Repair exterior concrete masonry unit and structural tile walls. Repair metal louvers, fascia, and wood trim.

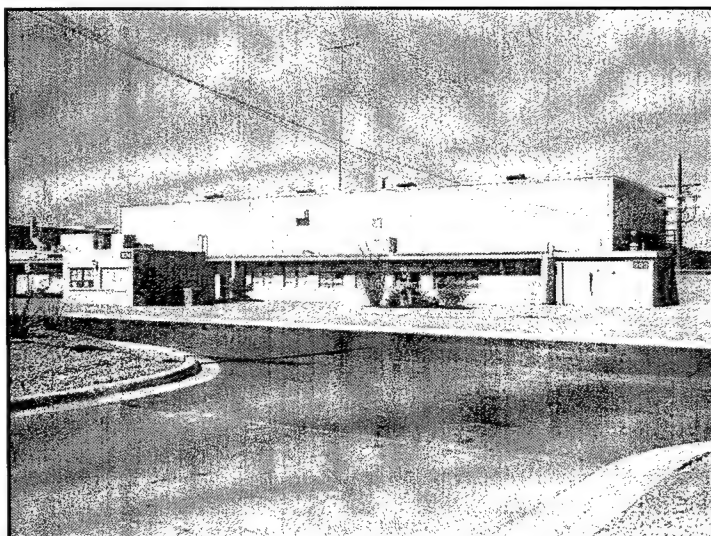
Comments: Building 823 does not retain historic integrity.

Comments: Most of the original doors and windows have been removed and/or replaced. Vinyl flooring, wainscoting, baseboard and dropped ceilings obscure original interior finish materials.

Suggested routine maintenance: Residue at metal fascia may indicate failure at built-up roof. Plug and paint sign holes at front entrance. Scrape, prime, and paint masonry foundations, and exterior walls. Fix drainage problem at north elevation. Remove vegetation at foundation.

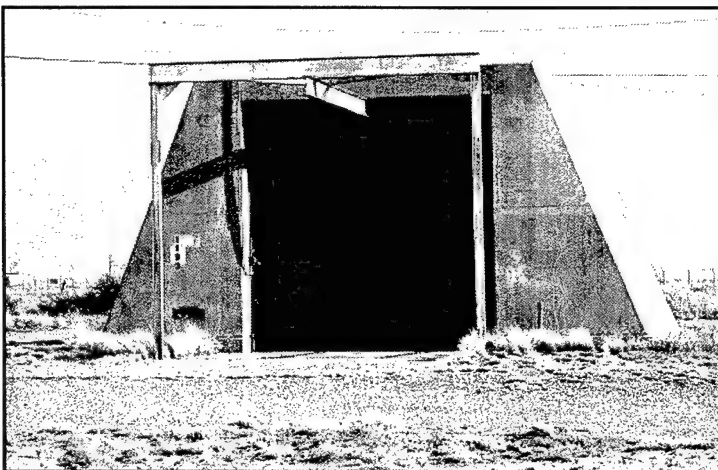
Building 1193 is a unique structure, designed primarily as a continuity check stand for testing boosters using unconventional fuels. It is made of cast-in-place, reinforced concrete walls on three sides, with one side left open. The structure is somewhat pyramidal in shape. The walls are two feet thick at the top, widening to seven feet thick at the bottom. A track and hoist system leads into the structure. Explosion-proof electrical switches are found at the interior. This structure has no doors and no windows. Although the builder is unknown, W. C. Kruger Company (Santa Fe, NM) provided the architectural work. No structural modifications to the original structure noted.

4-ton manual hoist mechanism supported by track I-beam and crane I-beam over track rail. The 80# track rail is set in the foundation slab. Explosion-proof switches located at the north wall. The concrete side walls are two feet thick at the top, widening to seven feet thick at the bottom.

Building 1193 remains essentially as it was originally constructed c1952, except for 4 x 10 wood planks missing at the back wall. The hoist mechanism has been removed. This building is no longer used as a check stand, and is currently abandoned. This structure should be managed in conjunction with Building 1194. Due to the unique design of Building 1193, and its association with Building 1194, recommend that this structure be reassessed once the fifty-year construction date is reached in the year 2002. Complete photo-documentation should be provided prior to any future modifications.

Suggested routine maintenance: The exterior concrete is spalling and should be cleaned and patched. Remove the vegetation at the foundation. Scrape and paint the metal track.

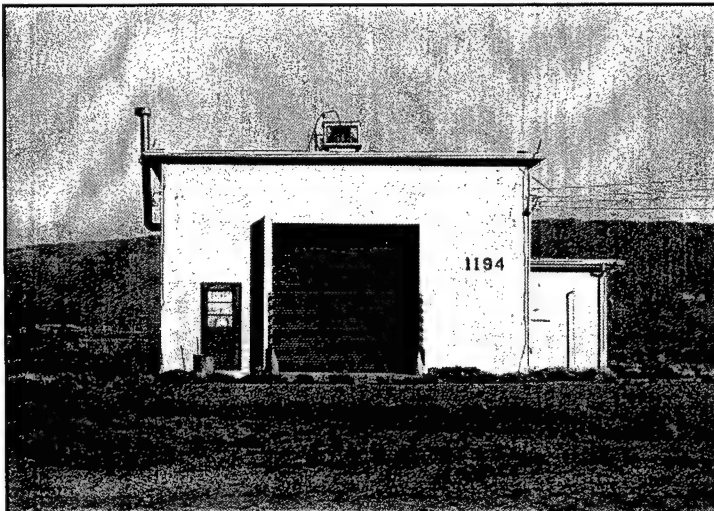
Building 1194 remains essentially as it was constructed c1952. The original floor plan layout included one main room and an equipment room. A small area in the northwest corner of the main room has been partitioned. No documentation was found pertaining to this modification. This minor partitioning of the main room is reversible. This building is no longer associated with either missile assembly and test activities or unconventional fuels storage, and currently serves as an equipment storage room for the 6585th Test Group. Construction drawings (1956: CE File # 1194-1) show that an addition to this building was planned. There is no indication that this addition was ever built. Because this building retains historic integrity, and may be eligible for the National Register under Criteria A and/or C once the 50-year construction date is reached in the year 2002, recommend that future modifications take essential design features into account. Note: One isolated occurrence of prehistoric artifacts was noted on the grounds north of the building, including one white chert core, and one secondary chert flake.

Suggested routine maintenance: Scrape, prime, and paint the exterior. Replace downspouts. Prune landscape plantings away from foundation.

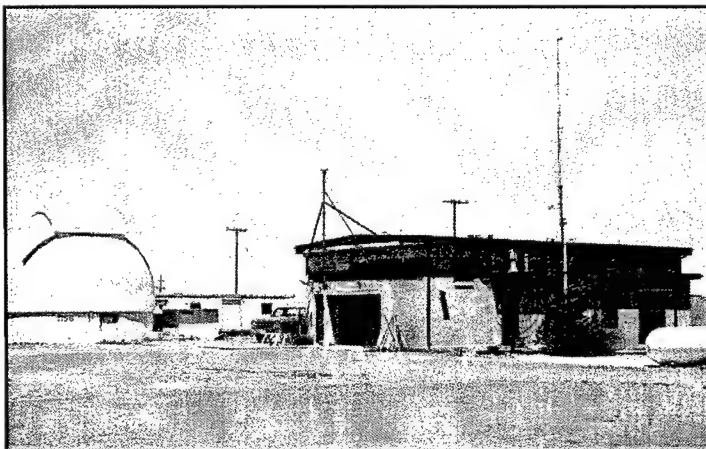
Everything except the roof at Building 1195 remains essentially as it was constructed in 1952. The addition of the low-pitch roof as part of a base-wide roof repair plan alters the exterior appearance. The original floor plan layout included one main room and an equipment room. Lavatory and storage partitions were later added to the main room. This minor partitioning of the main room is reversible. This building is no longer associated with fuels storage. This building continues to be associated with the nearby dome as equipment storage only. According to Real Property Accountable Record/1195, ownership of this building was transferred from the White Sands Missile Range to Holloman Air Force Base c1964. Recommend that this facility and the other unconventional fuels storage/missile test facilities in the vicinity be reassessed for National Register eligibility as individual properties or contributing features once the fifty-year construction date is met (c2002). Recommend photo-documentation of these buildings in the interim prior to alterations to any essential design elements. Suggested routine maintenance: Repair ductwork in equipment room. Scrape, prime, and paint exterior walls.

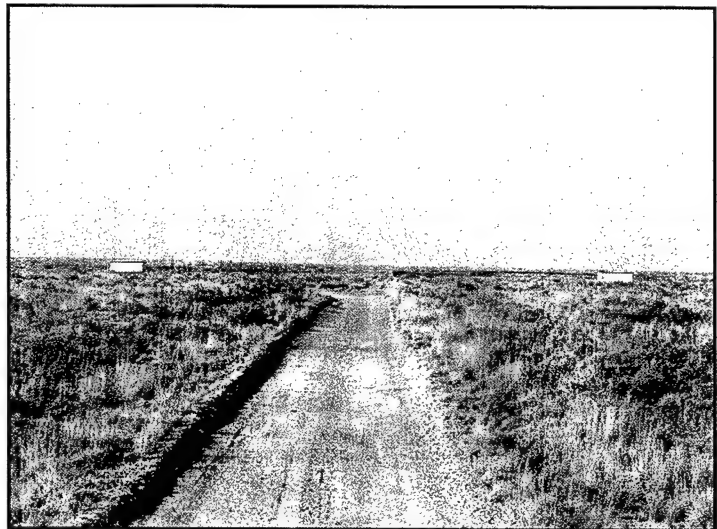
Buildings 1197 and 1198 (facing northwest). Summer 1995.

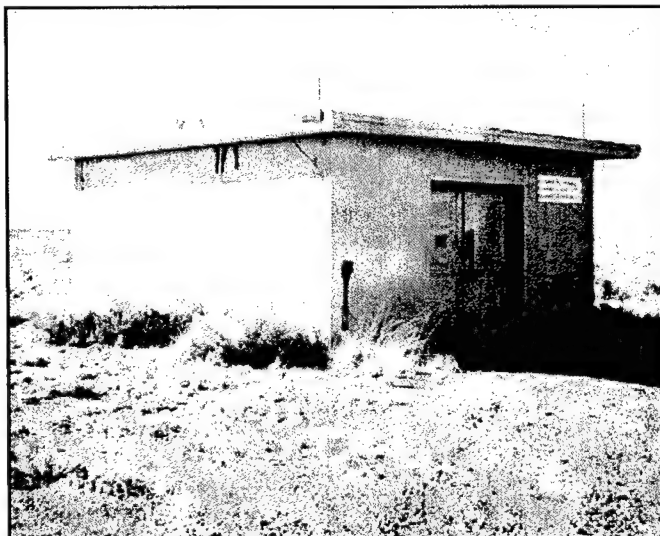
As ancillary storage facilities, neither building meets National Register of Historic Places criteria as individual properties. Both buildings retain all aspects of historic integrity. Each is in need of routine maintenance. Although not mandatory, recommend that photo-documentation prior to future modifications document these storage facilities. Although perhaps only of interest at a local level, Buildings 1197 and 1198 would qualify as contributing features in a basewide Cold War-era Multiple Property nomination.

Suggested routine maintenance: Stress cracks are evident at the building exterior, running from the bottom center to the top front corner. These cracks were most likely caused by the weight of the sliding door and the sudden impacts caused by opening and closing the slider door panels. Efflorescence at the interior walls indicates water infiltration. Recommend repairing or replacing the built-up roof in kind, sealing the interior wall surfaces, sealing and painting the exterior walls, repairing the cracks in the masonry, and repairing the metal door track.

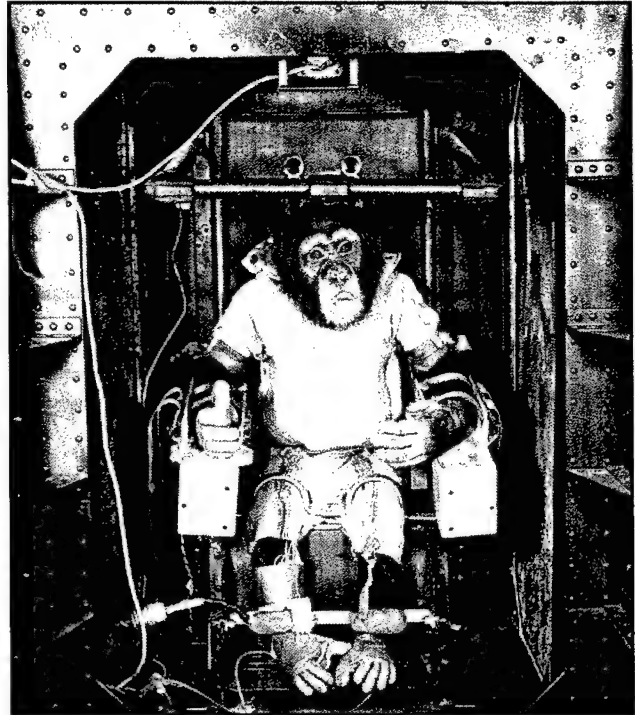
RG 342-B, Vol. II, 09-002, Archives II.

Chimpanzee Rapid Decompression Experiments [Projects ESP 920E-7210 and -9909]: Decompression experiments sponsored by NASA were undertaken to support the upcoming Gemini and Apollo flights. In order to find out how astronauts might respond to a sudden loss in cabin pressure, nine Holloman chimpanzees were exposed to varying periods of decompression. The decompression chamber, made by General Electric, was capable of decompressing the tank from a chamber altitude of 35,000 feet to a near vacuum in less than one second. At the same time, scientists set up an oxygen system to recompress the tank within five seconds (Cornett n.d.a.: 212). The chimps were able to survive rapid decompression without damage to the central nervous system, allowing "cautious extrapolation" to humans (Cornett n.d.a.: 213).

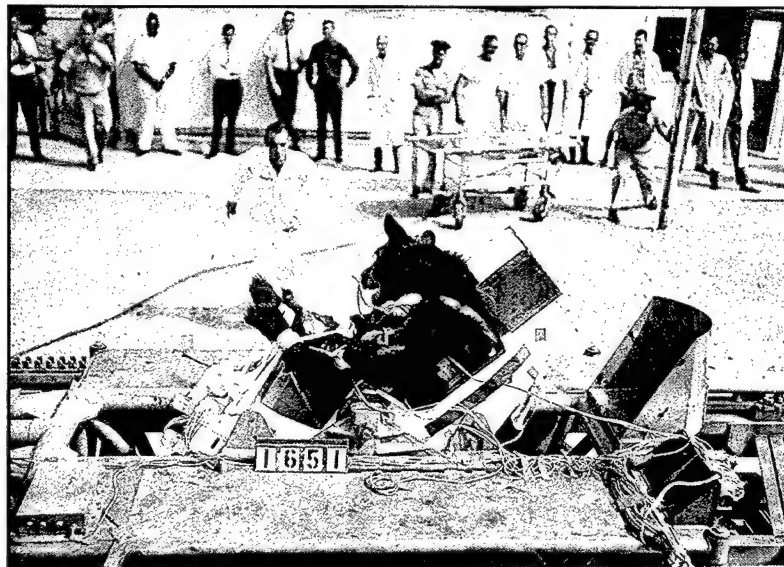
"An anesthetized American Black Bear is subjected to a forward-facing impact on the Daisy Decelerator in conjunction with the Apollo test at Holloman AFB, NM. 3 September 1963." U. S. Air Force photo.

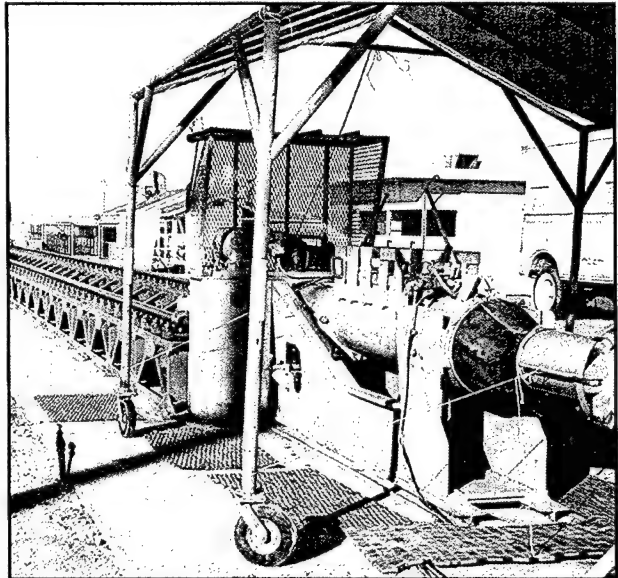
RG 342-B. Vol II. 06-042. Archives II.

The track consisted of two solid steel rails, three inches in diameter set five feet apart, centerline to centerline. The rails were supported by a steel superstructure bolted to a reinforced concrete foundation. In February 1961, a contract was awarded for the track extension, which was accepted for operational use in October 1962. Perhaps the most important mechanical component of the Daisy Decelerator was the waterbrake. This assembly had two major parts, the waterbrake cylinder and a piston which was part of the sled. The operation of the brake depended "on the transfer of energy from the moving sled to the moving water" (Chandler 1967: 31).

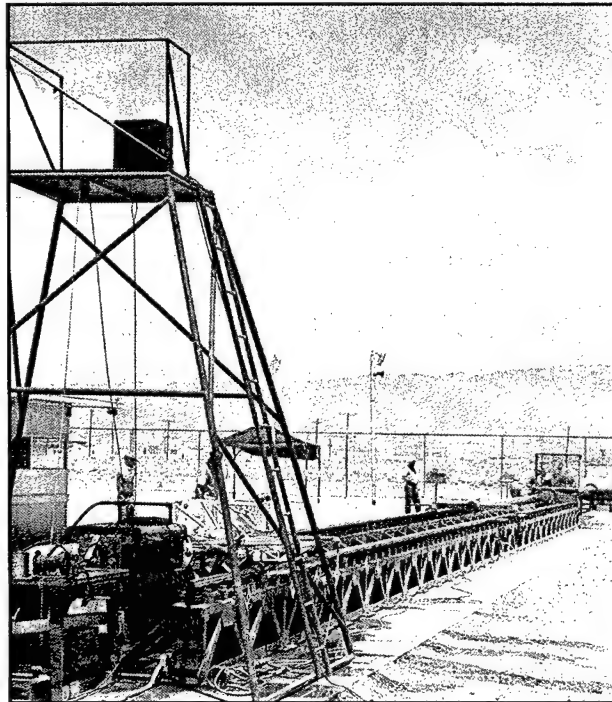
"Daisy Deceleration: 240-foot test track at the Aeromedical Field Laboratory, Holloman AFB. 2 January 1962." U. S. Air Force photo. Facing northwest.

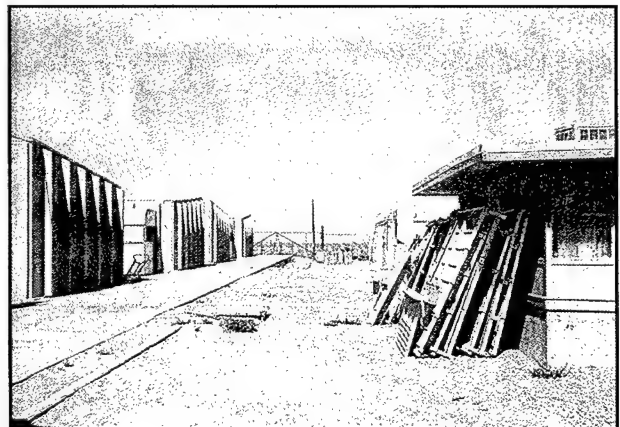
(Left) "New air propulsion unit shown following test run on the Daisy Deceleration Track at Holloman AFB, NM. 21 June 1960." U. S. Air Force photo. Facing southwest.
